Foundation Problems and Solutions at the Bridge River, Powerhouse No. 1

H. Taylor
B. C. Hydro

A. P. Joseph
B. C. Hydro

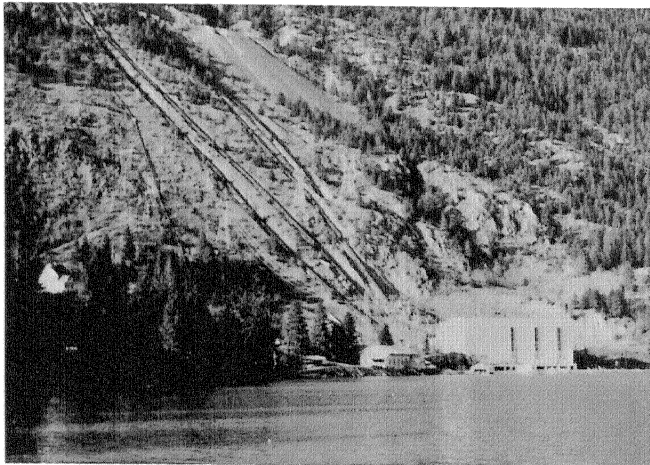
Fig. 2. Powerhouse No. 1 and Penstocks 1 to 4, April 1983.

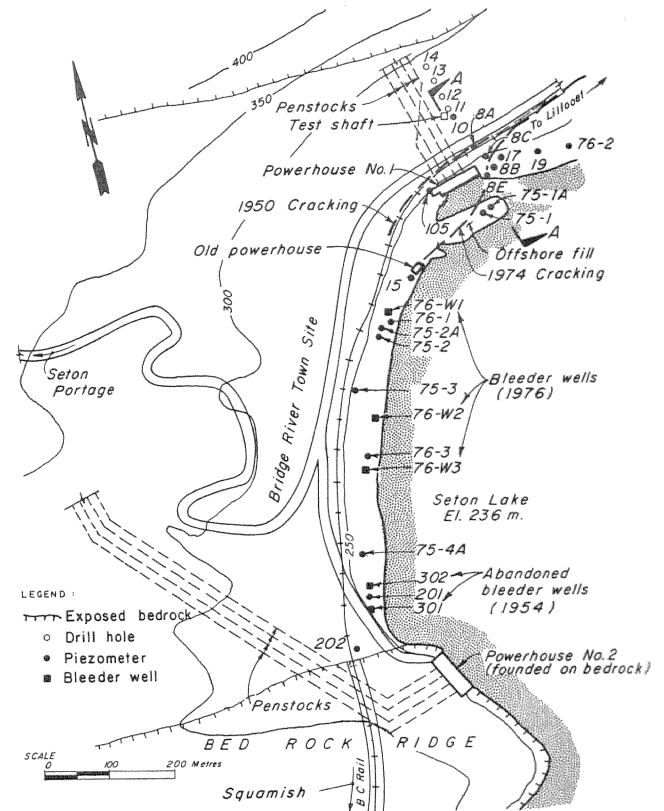
Fig. 3. Site Plan - 1983

The powerhouse is situated on the north shore of Seton Lake at the foot of a steep mountain slope, see Fig. 2. The upper portion of the slope consists of exposed bedrock, and the lower portion consists of overburden material extending into Seton Lake at a relatively flat slope, as shown on Fig. 3.

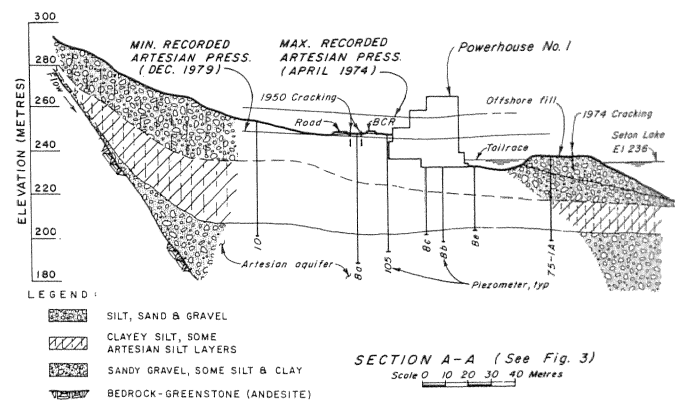
Fig. 4. Geological Section through Powerhouse No. 1

The overburden material near Powerhouse No. 1 consists of a dense glacial till to a depth of about 20 m. Below the glacial till is a zone of clayey silt also about 20 m thick underlain by artesian silt, sand and gravel of unknown thickness. Drillhole No. 76-3, installed approximately midway between Powerhouse Nos. 1 and 2, extended to a depth of approximately 110 metres without encountering bedrock. The impervious clayey silt stratum extends out beneath Seton Lake confining flow from the uphill area within the underlying aquifer. A geological section through Powerhouse No. 1 is shown on Fig. 4.

The catchment area extends over about 14 km² and feeds the aquifer between the powerhouses. Run-off water from the mountainsides flows through the steep fractured bedrock to the basal sands and gravels towards Seton Lake, where it is restricted by the overlying clayey silt strata, see Fig. 4. The uphill feed of ground water into the aquifer and the restricted outlet at lake level causes high artesian pressures during each spring's snowmelt and runoff. High artesian pressures develop in the aquifer below the powerhouse and below the entire shoreline.

As an alternative solution Dr. Terzaghi recommended that an offshore fill be placed in front of the powerhouse and that material be excavated from the hillside behind the powerhouse, 68,000 m³ of fill was placed. Fig. 5 illustrates the location of the offshore fill. Fig. 4 illustrates a typical section through the fill and Powerhouse No. 1.

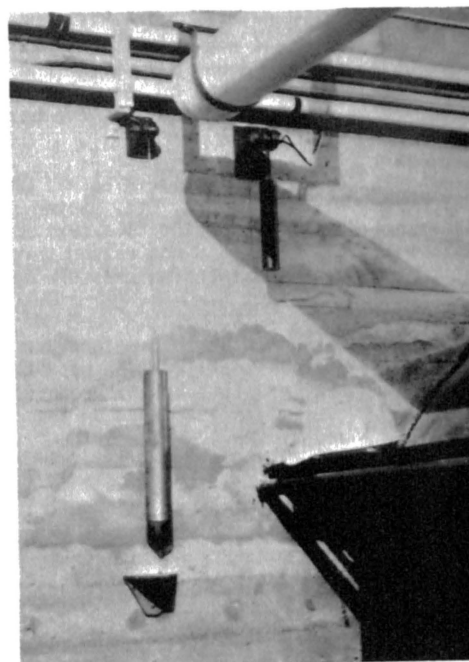
Fig. 6. Instrumentation Details - 1951

In order to record and assess powerhouse movement instrumentation procedures were established, in October 1951, by Dr. Terzaghi and have essentially been followed to date. These included artesian pressure gauge readings, settlement observations, tilt readings on columns, elongation of penstock tunnels and crack width measurements. Most of the instruments are read monthly, the artesian pressure gauges are read more frequently in times of high artesian pressure. Details of some of the instrumentation are shown on Fig. 6. Terzaghi's penstock elongation measuring device is shown on Fig. 7.

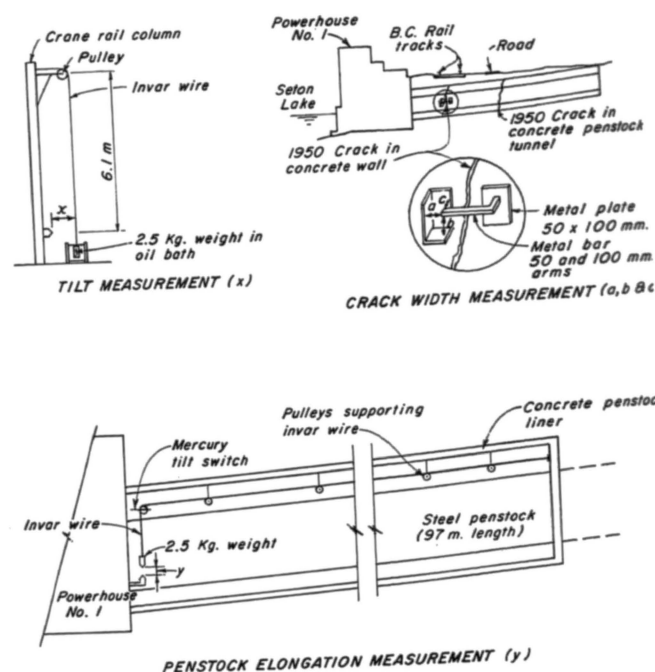
Fig. 7. Terzaghi's Penstock Elongation Measurement Device, April 1983

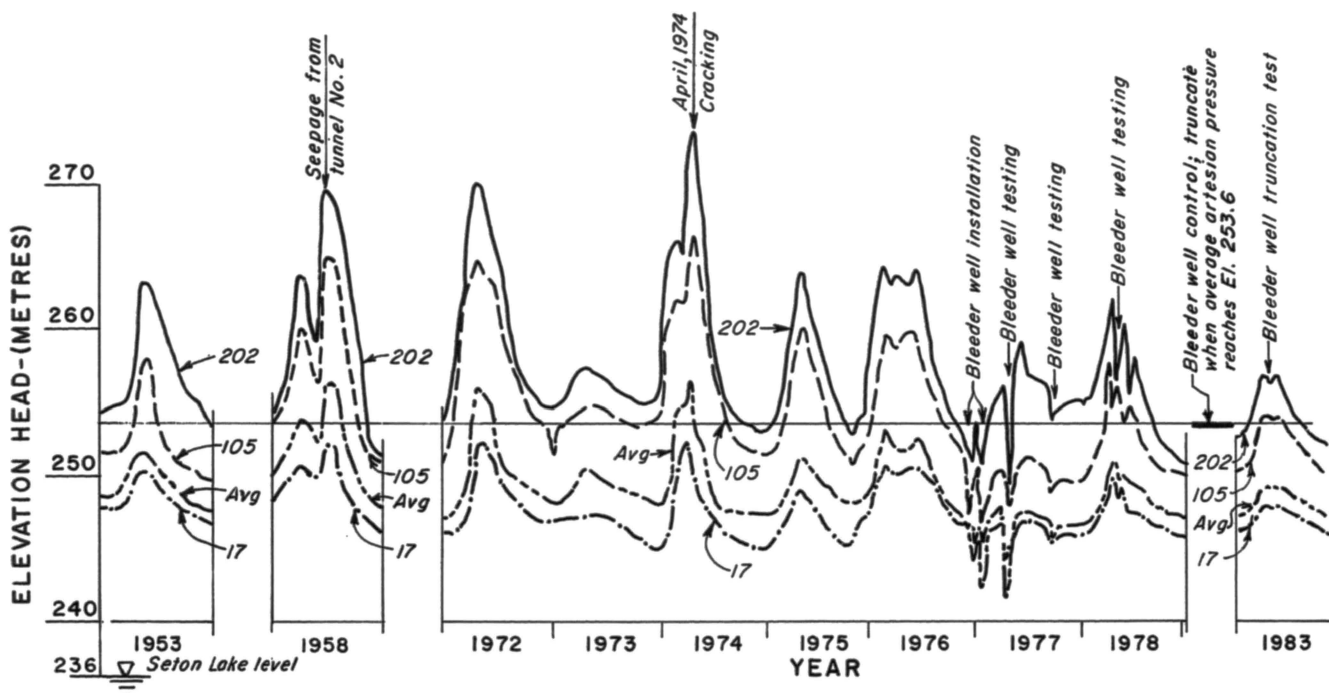
Fig. 8. Variation of Artesian Pressure 1953 to 1983

In June 1958 the penstock tunnel for Bridge River Powerhouse No. 2 was holed through resulting in a flow of about 20 l/sec. This flow disappeared into the talus material part way down the hillside and fed water into the underlying aquifer causing a steep rise in the artesian pressure under the powerhouse (see Fig. 8) that was out of sequence with the annual runoff peak artesian pressures. The tunnel flow was piped away by 8 July 1958 and the artesian pressures subsided near both Powerhouse Nos. 1 and 2 without causing any ground cracking or subsidence.

Instrumentation data indicates that the powerhouse acts as a rigid unit and tilts slightly between summer and winter due to severe changes in temperature. Also, the instrumentation shows that the high artesian pressures in early spring correspond approximately with the cyclical movement of the powerhouse. Piezometer installation commenced in 1950, sufficient were functioning in 1953 to permit the average artesian pressure to be determined. Fig. 8 illustrates the variation in artesian pressure for selected years between 1953 and 1983.

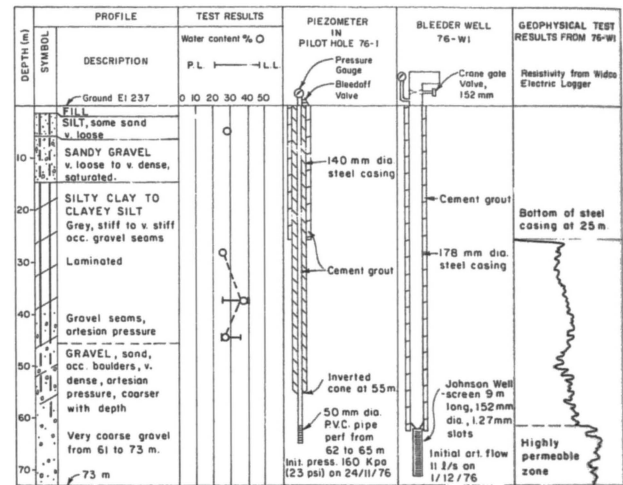
Fig. 11. Typical Drillhole Log

In 1975, holes were drilled along the Seton Lake shoreline between Powerhouses Nos. 1 and 2. These holes, encountered stratigraphy similar to that of the previous drilling, except that a very coarse zone was found at depth in the aquifer, between Powerhouse Nos. 1 and 2. A typical drill log is shown on Fig. 11.

Three bleeder wells were installed approximately six metres from the pilot hole piezometers. Bleeder wells 76-W1, 76-W2 and 76-W3 were installed to depths of 72.5 m, 92.5 m and 87 m respectively. The lower 9 m of each well consists of six 1.5 m lengths of stainless steel Johnson well screen. The well screens, 152 mm diameter with a 1.27 mm slot size, were wedged tight with a leather packer to the bottom of the 203 mm O.D. steel casing. Typical bleeder well and piezometer installations are shown on Fig. 11.

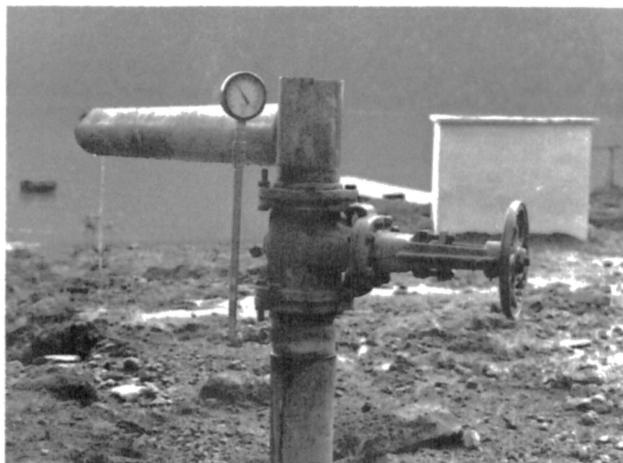
This method of development subjected the aquifer near the well screen to higher pressures than would occur under artesian flow conditions. This removed fine silt and sand from around the well screen producing a well-graded natural granular filter. After development, all wells yielded perfectly clear, silt-free water and have been clear every since. After completion of each bleeder well they were boxed in and are used as piezometers except during bleeder well operation, see Fig. 13 for a typical completed installation.

Fig. 13. Bleeder Well 76-W1, typical Housing in background, January 1977

Every year in January each bleeder well is tested on different days, by completely opening the valve and allowing the artesian water to flow unrestricted for 30 minutes. The free flow of artesian water from each bleeder well has to date always been clear and averages about 23 l/sec.
